REPORT OF INVESTIGATION
(UNDERGROUND COAL MINE)

NONINJURY COAL OUTBURST

Virginia Pocahontas No. 3 Mine (ID No. 44-01520)
Island Creek Coal Company
Vansant, Buchanan County, Virginia

March 4, 1987

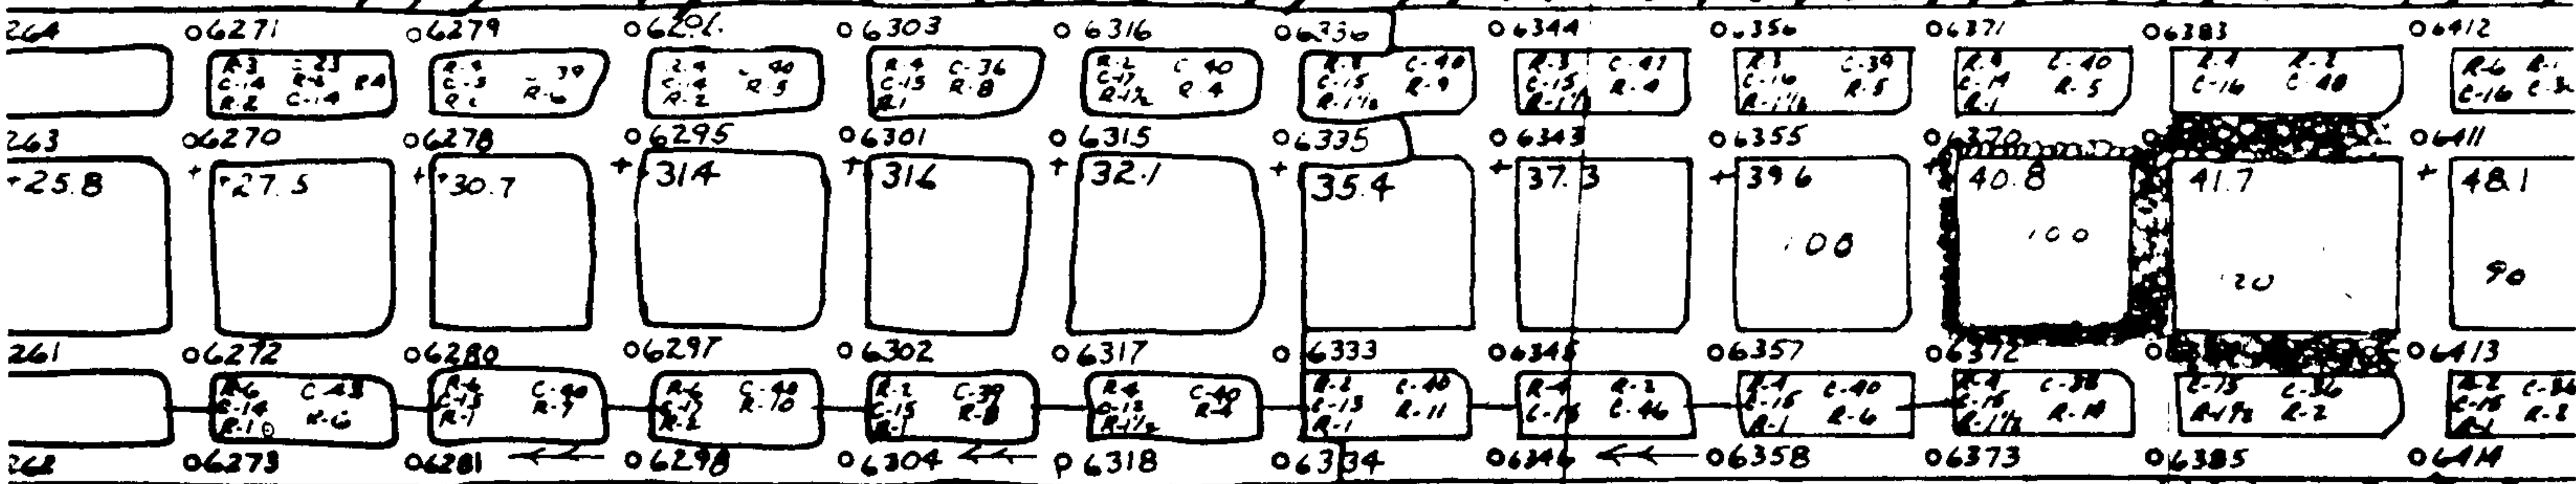
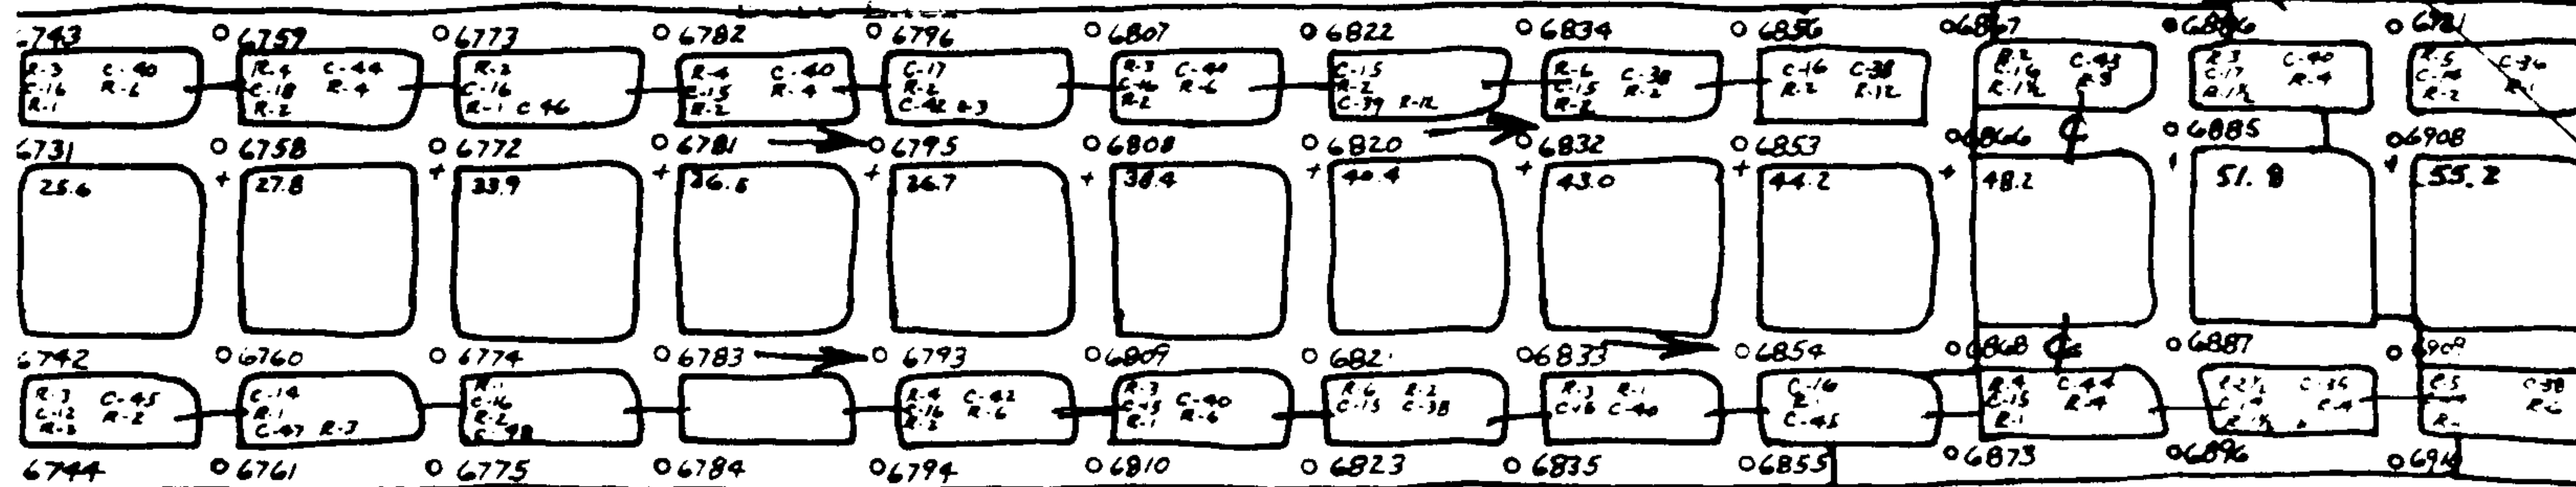
SKETCH OF NONINJURY COAL OUTBURST

4. As a result of a fatality caused by an outburst of a larger pillar adjacent to the tailgate entry in a sister mine, Beatrice, Island Creek Company's development plans for longwall mining were modified in this mine in March 1976. The change resulted in the 80-foot by 80-foot load bearing pillar, previously developed adjacent to the tailgate entry, being developed in the middle of the development panel, so that a 30-foot by 80-foot yielding pillar located adjacent to the tailgate entry, would serve as a buffer from the effects of possible bumps or outbursts from the larger pillar. The modified development plan was used in the area where this outburst occurred and is shown on the portion of the attached mine map.

5. The outburst occurred on two pillars adjacent to Survey Station 6384. The inby pillar had been developed 80 feet wide and 100 feet long and the outby pillar had been developed 80 feet wide and 80 feet long. The 80-foot by 100-foot pillar was the largest load bearing pillar on the 6 development panel.

6. The outburst was confined to the load bearing pillars, except for airborne dust, and coal was not expelled into the tailgate entry, indicating that the 30-foot by 80-foot buffer pillar had functioned as planned.
